Case Study: Native Vegetated Mat

Geneva Lake, Fontana, Wisconsin

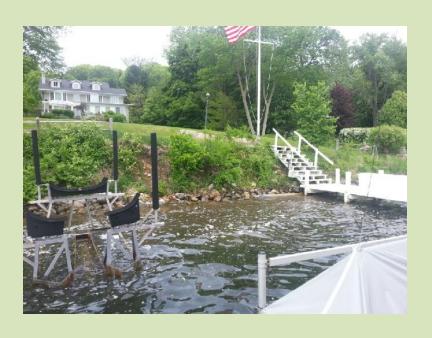
The existing site is an eroded shoreline at a beautiful residential lake property in southeast Wisconsin. Wave energy has undercut the shoreline and the resulting erosion has destabilized the slope to the point of making the Shore Path, a Geneva Lake scenic icon, a perilous adventure. The lack of stable soils prevented vegetation from growing and protecting the steep slope.

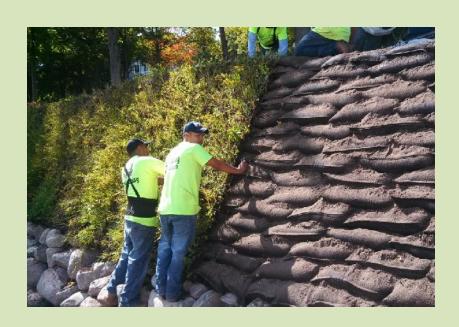
Vegetated mats consist of a coir reinforcing mat, soilless growing medium and native vegetation. Mats are rolled over the face of the Envirolok bag units and stapled into place. The micro-punched fabric of the Envirolok units allows vegetation to not only root into the unit fill and backfill soil, but also into the parent slope, creating a reinforced and stabile monolithic structure. The only maintenance required is periodic watering of the vegetated mats until they are sufficiently rooted to the bag units.

The shoreline is protected by the rip rap boulders. The slope is stabilized and reinforced by the Envirolok Segmental Retaining Wall System. Native vegetation sequesters sediments and pollutants from entering the lake water, cleans surface runoff and traps excess nutrients from turfgrass fertilizers and provides habitat for pollinators and wildlife. The buffer area between the Shore Path and the crest of the slope has been restored, making walking the path safe again. Next Spring, Summer and Fall the diverse native plant species will explode with seasonal colors and textures, beautifying the Geneva Lake shoreline!
